MEDICINES INSPECTORATE REPORT ON THE CURRENT STATUS AT THE PROTEIN  
FRACTIONATION CENTRE, EDINBURGH AS OF OCTOBER 1 1981

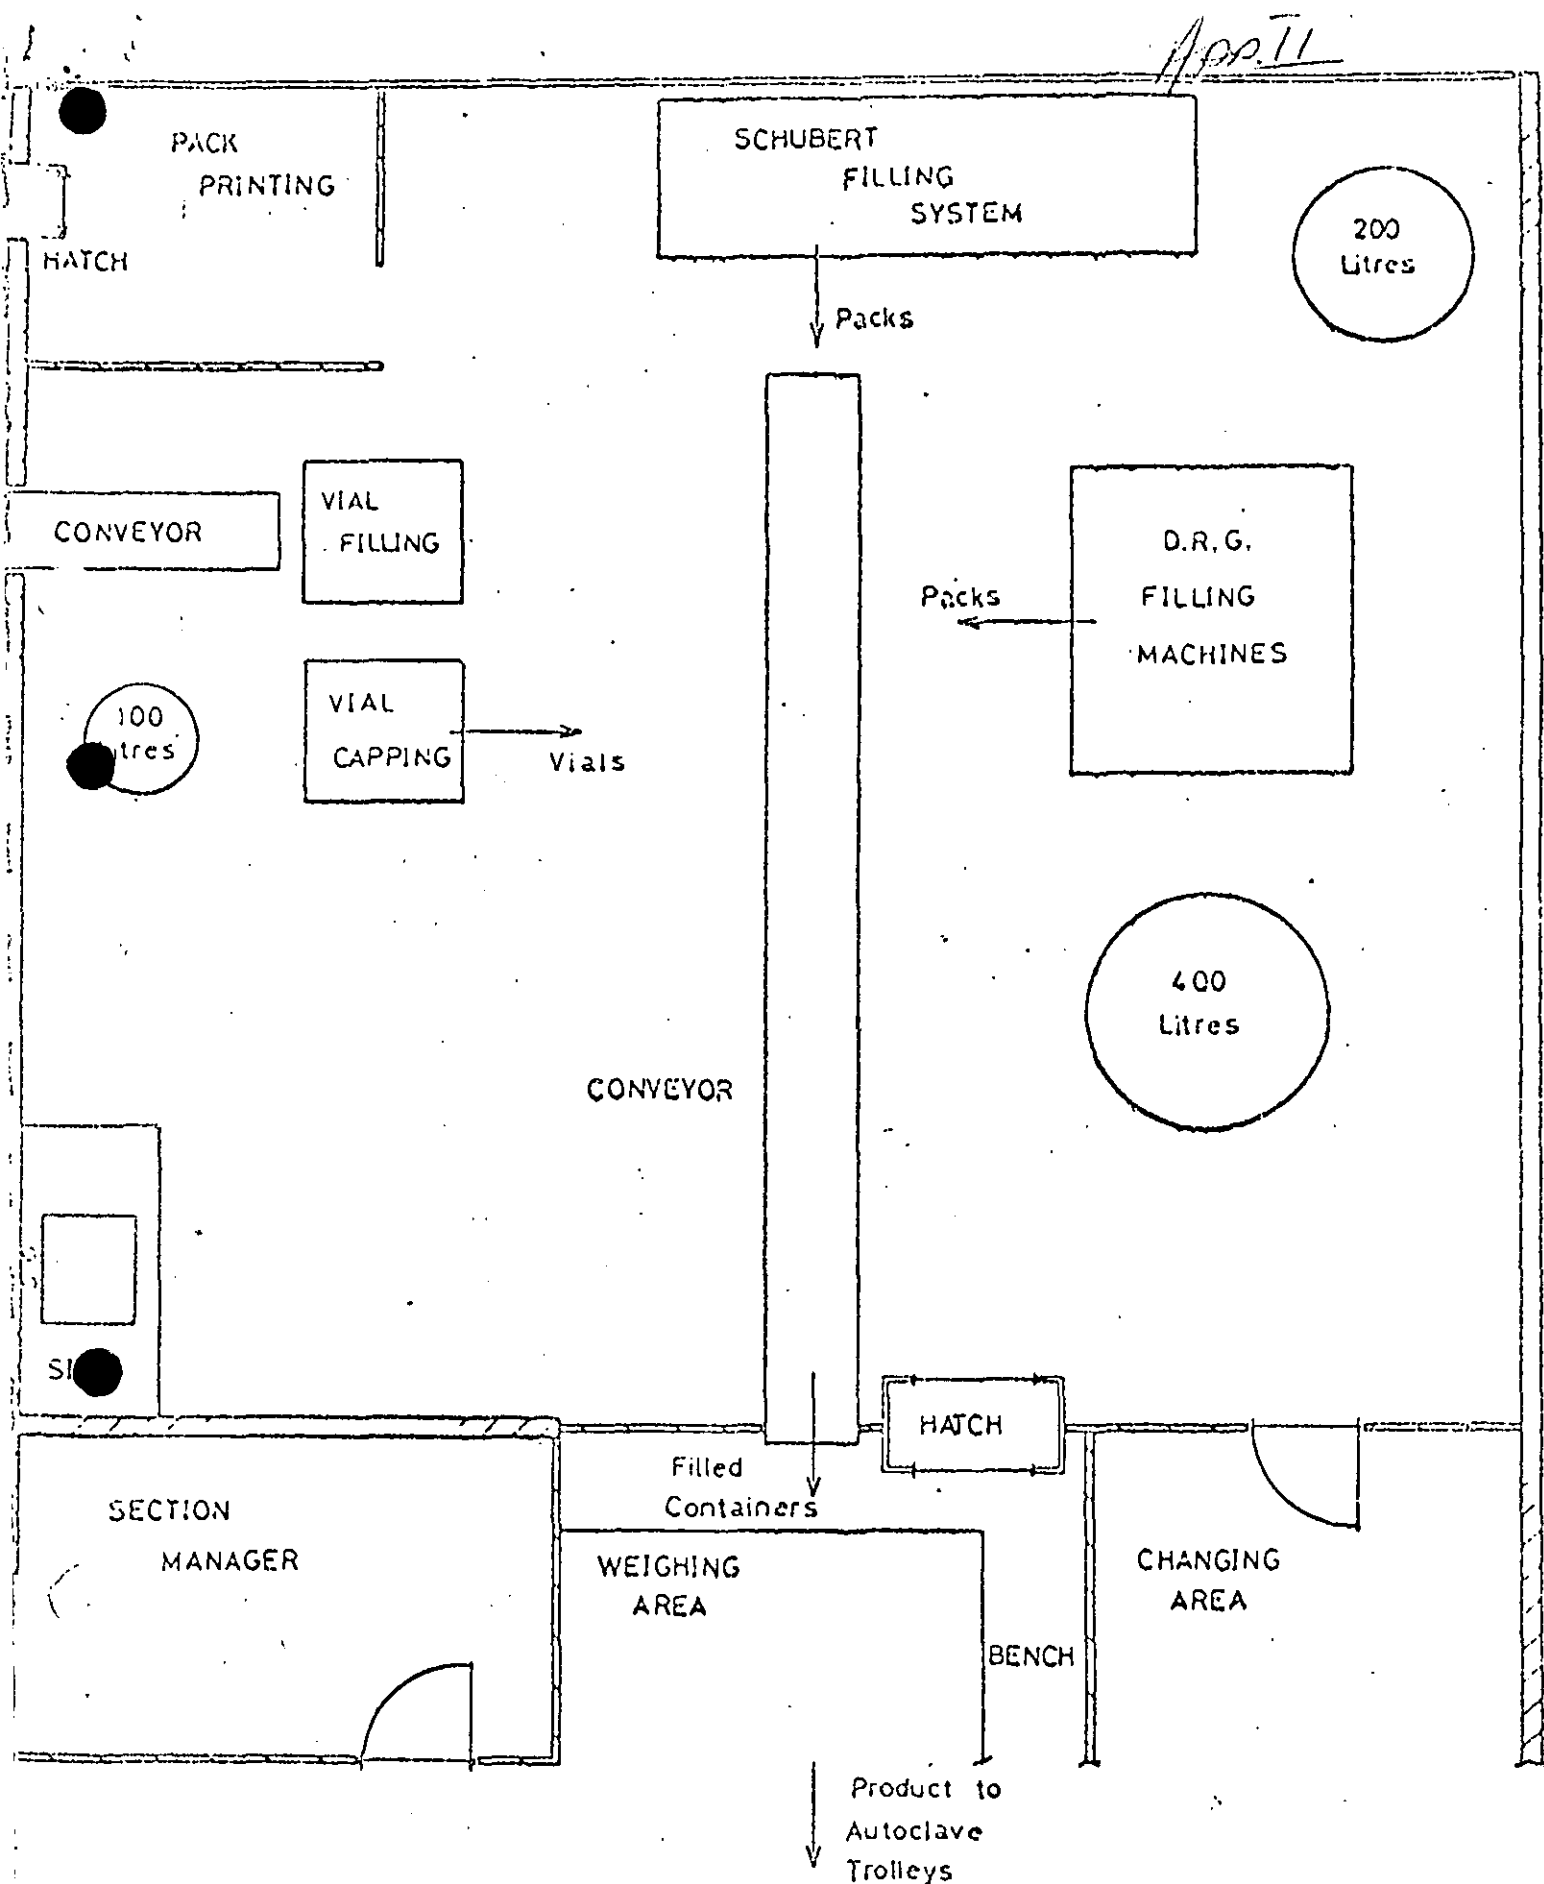
Original					Protein Fractionation Centre EDINBURGH
Date	2-9-81				
Drawn	SK				
By					
		REVISIONS	Date	Name	
SCALE	Title				Drg. No
NTS	PREP FILLING AREA (G.67) -				169

The proposed equipment layout (drawing 169) as detailed in the PFC Response to the Draft Report of 11 and 16 June is acceptable.

The surface finishes of the walls and the crevice between wall and ceilings is still not acceptable.

With the very cramped conditions provided, the implementation of upgrading of room G67 to accommodate bag printing must be a priority (see 3.4).
